Discovery STS-114

SSME Flight Readiness Review

June 29-30, 2005

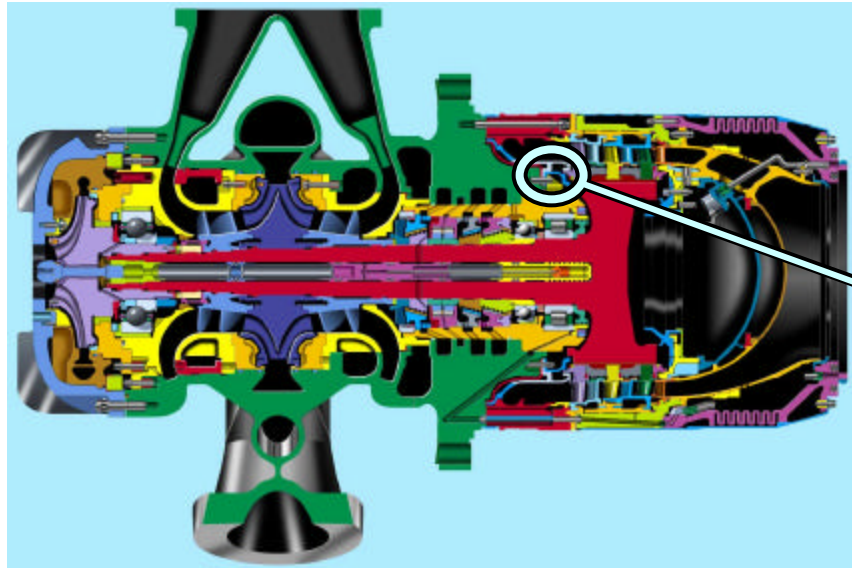
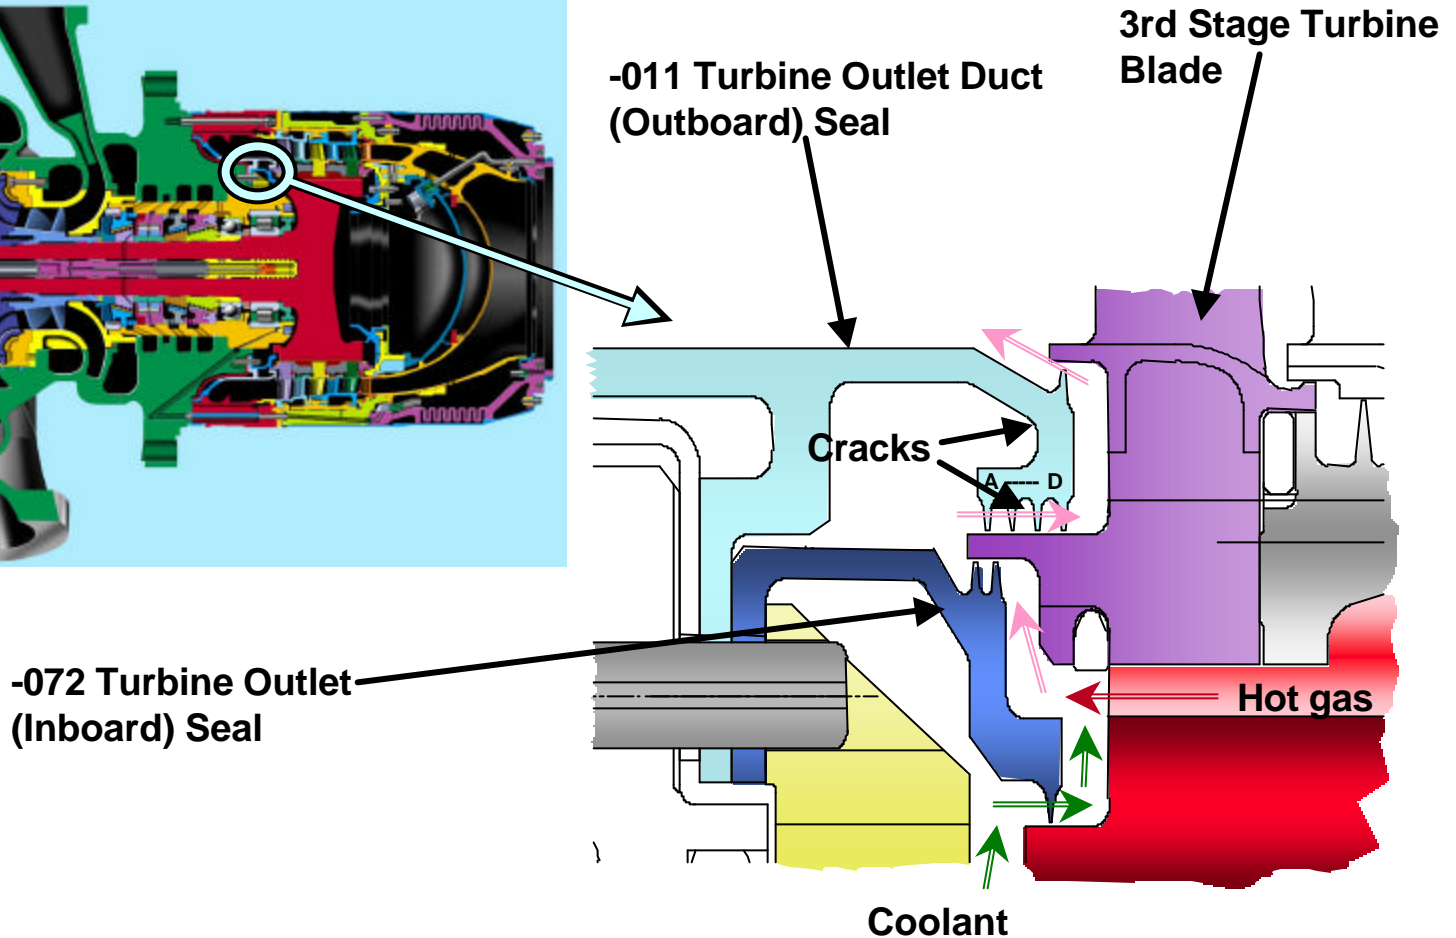
- Cracking of Turbine Outlet Duct Seal creates FOD concerns to downstream components

- Multiple seals found with radial cracks in 4-tooth seal during overhaul and recycle operations
 - 3 flight configuration seals
 - Severity varies from single crack in one tooth to multiple cracks in all four teeth
 - 2 non-flight, early development configuration seals
 - Multiple cracks in all four teeth
- Single occurrence of circumferential web cracking
 - Intermittent, 360 degrees, one location with through crack
- Cracking had no impact on seal functionality or engine operation
- No FOD generated

HPOTP Knife Edge Seal

Outboard Seal (-011) Cracking

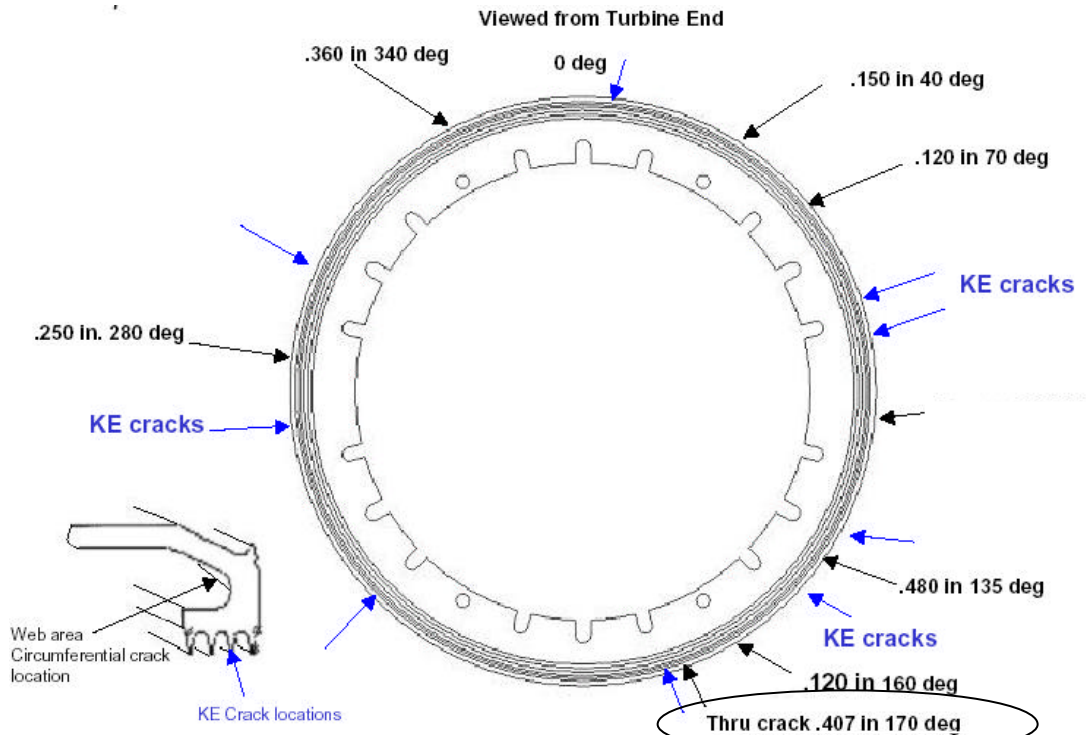
HPOTP 8016R4 Outboard Seal (-011) Crack Indications

Radial Tooth Crack

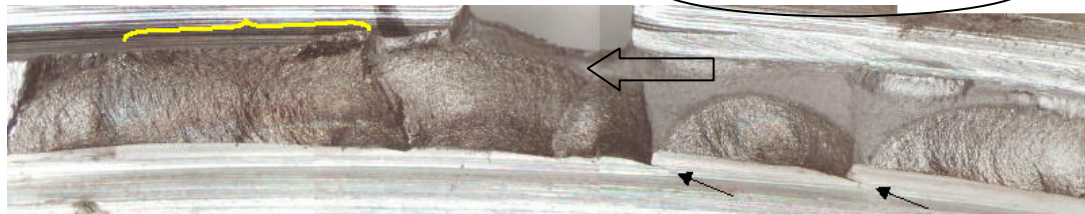
One web through crack showing crack growth deceleration

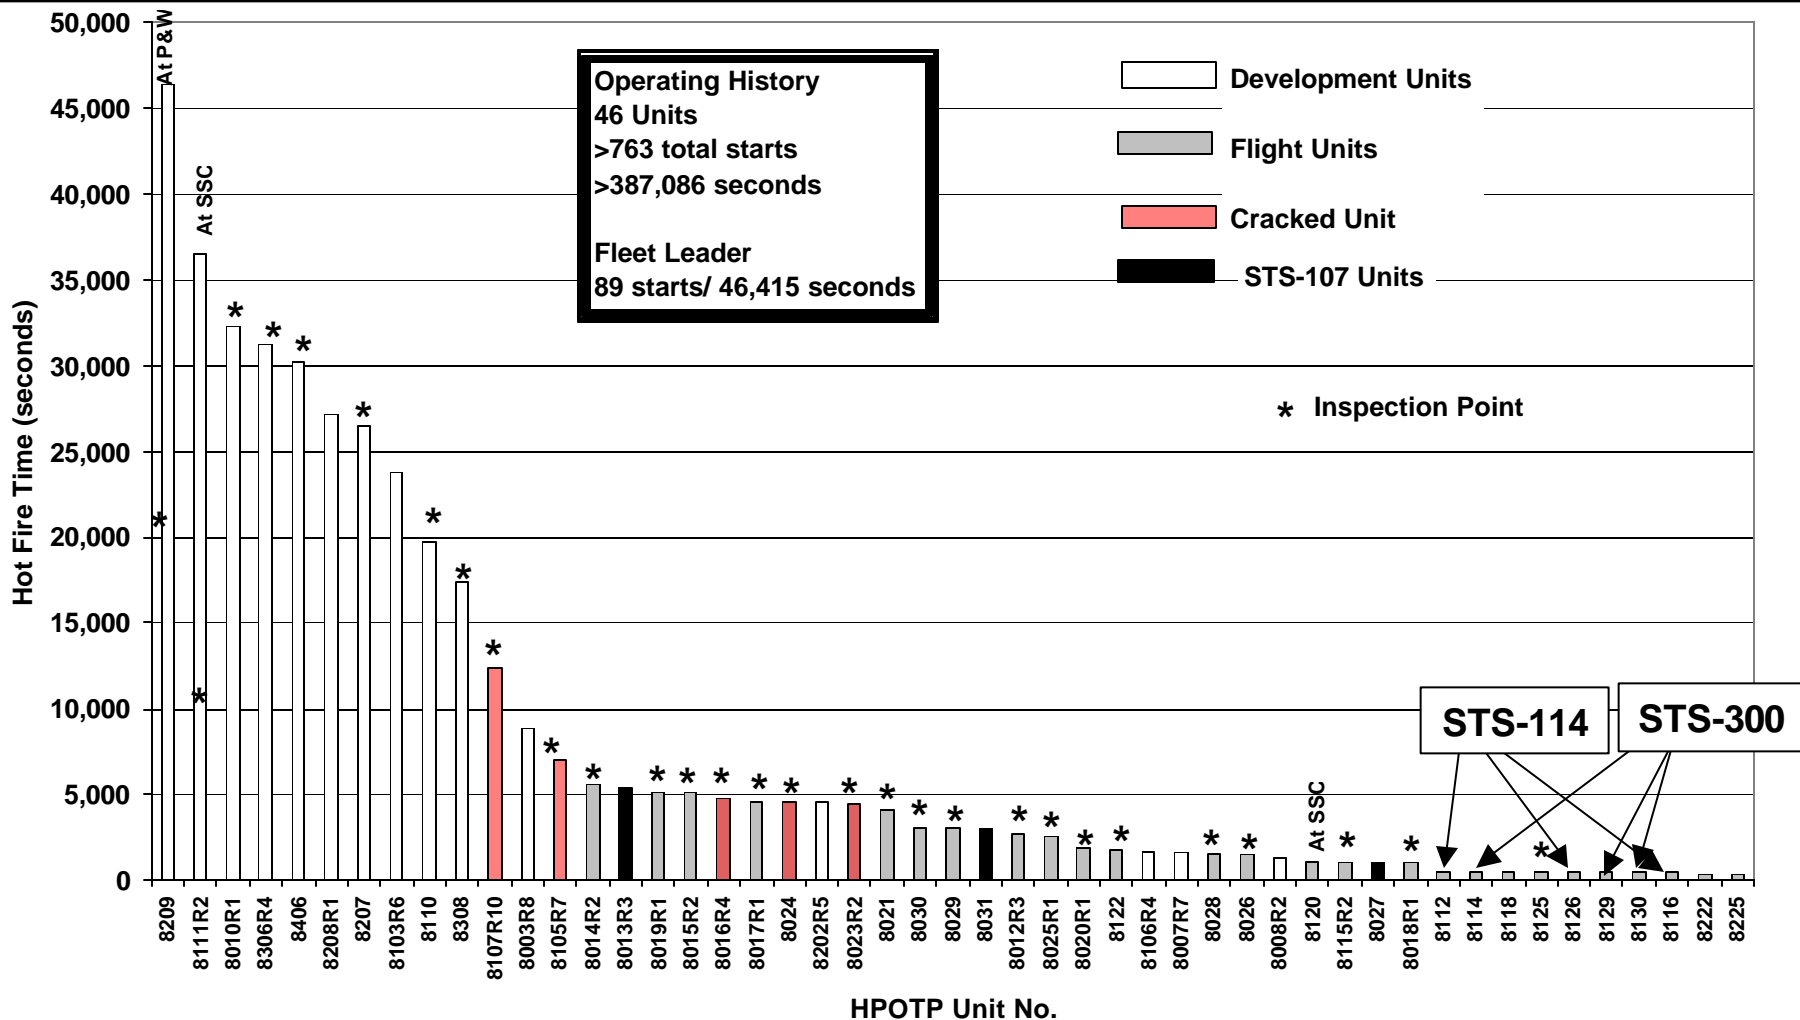
Outboard Seal (-011) Cracking

STS-114 units very low time relative to demonstrated experience with cracking

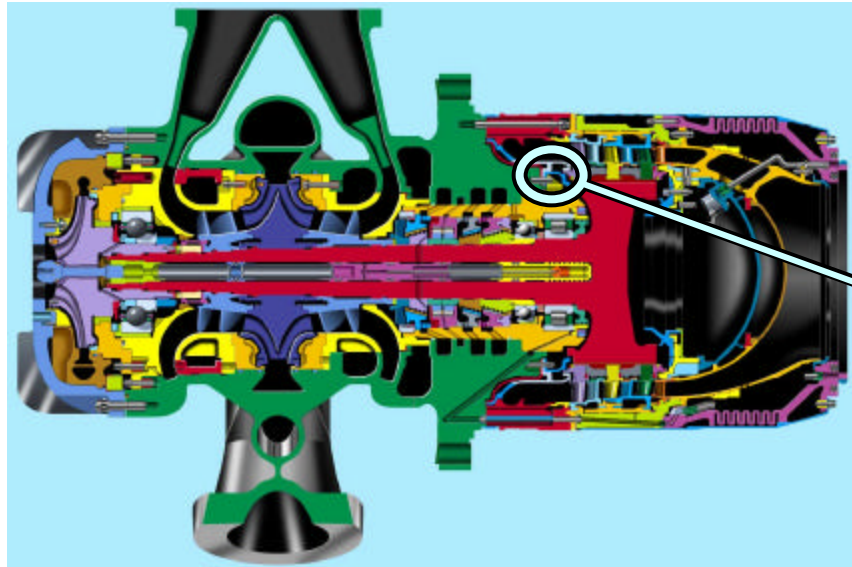
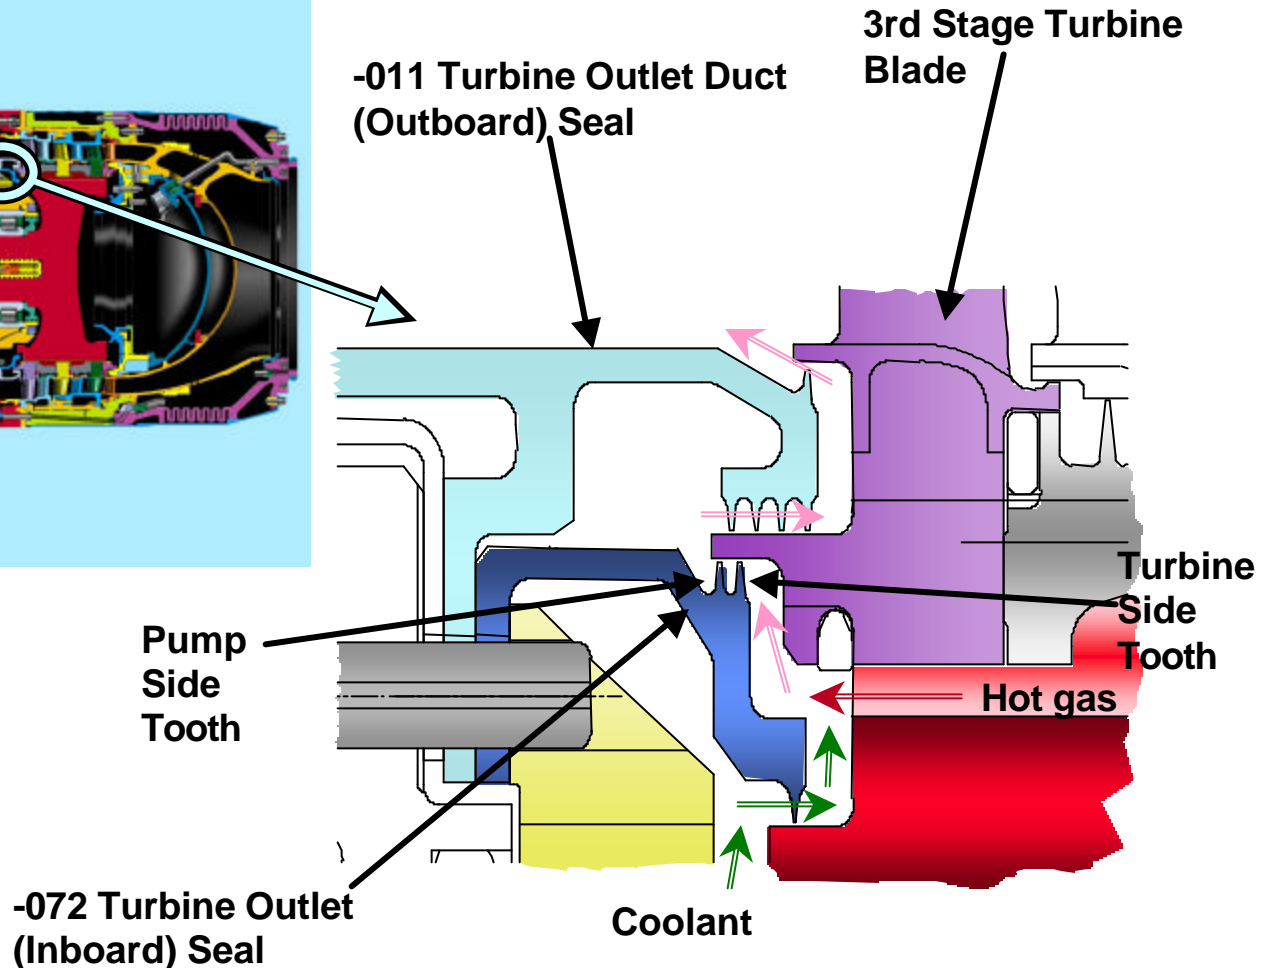
Inboard Seal (-072) Cracking

- Loss of Turbine Inboard Seal knife edge creates FOD concerns to downstream components
- Loss of both knife edge teeth could impact stability of outboard (-011) seal resulting in cracking and downstream FOD concerns

- Cracks and material loss found in knife edge 2-tooth seal during scheduled overhaul of 5 flight HPOTPs
 - Pump side tooth cracking and material loss on 4 of 5 seals
 - 3 of 5 had turbine side tooth cracking also (no material loss)
 - Pump side tooth cracking only (no material loss) on one seal
- Cracking and material loss had no significant impact on seal functionality or engine operation

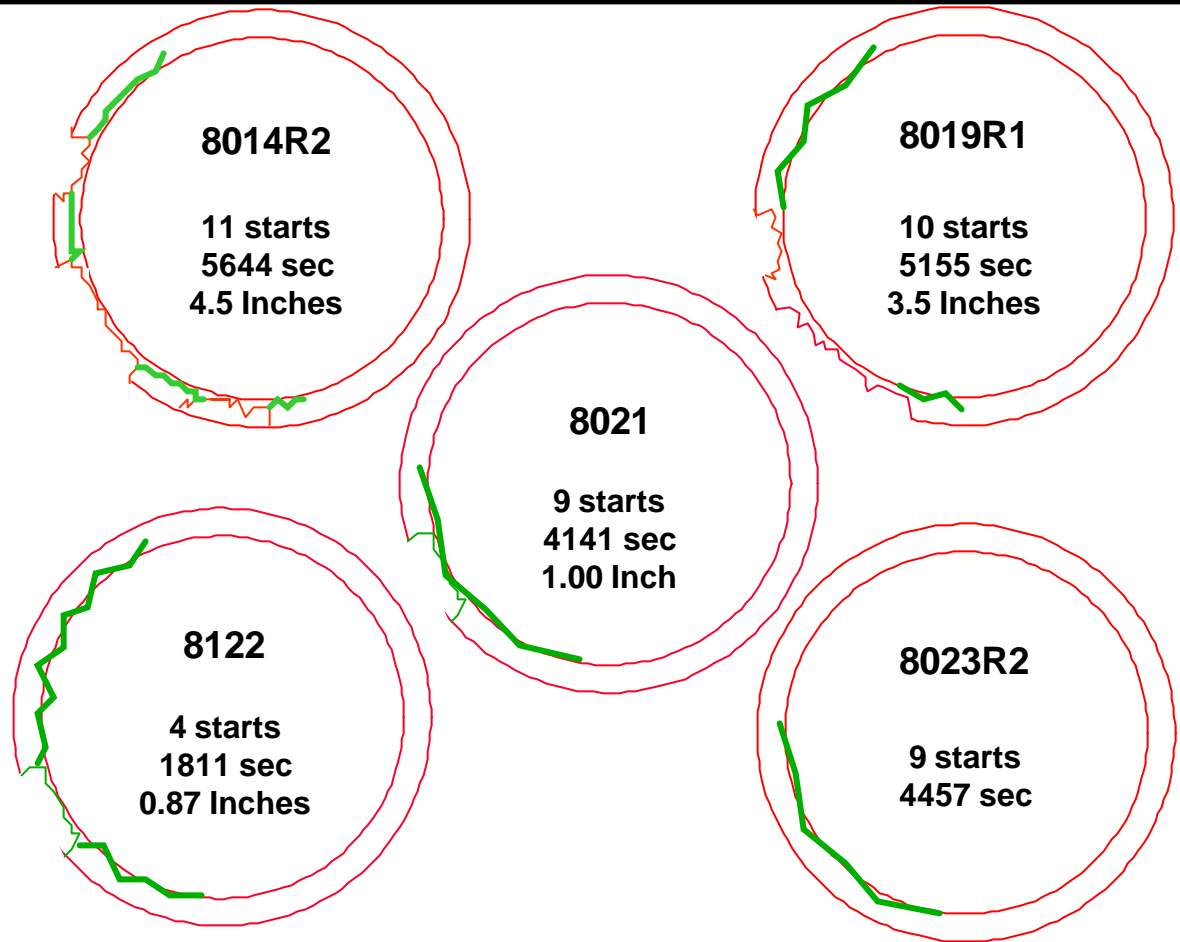
-072 Seal Pump Side Tooth Crack Map

— Crack Region

Crack patterns show loss of entire tooth is unlikely

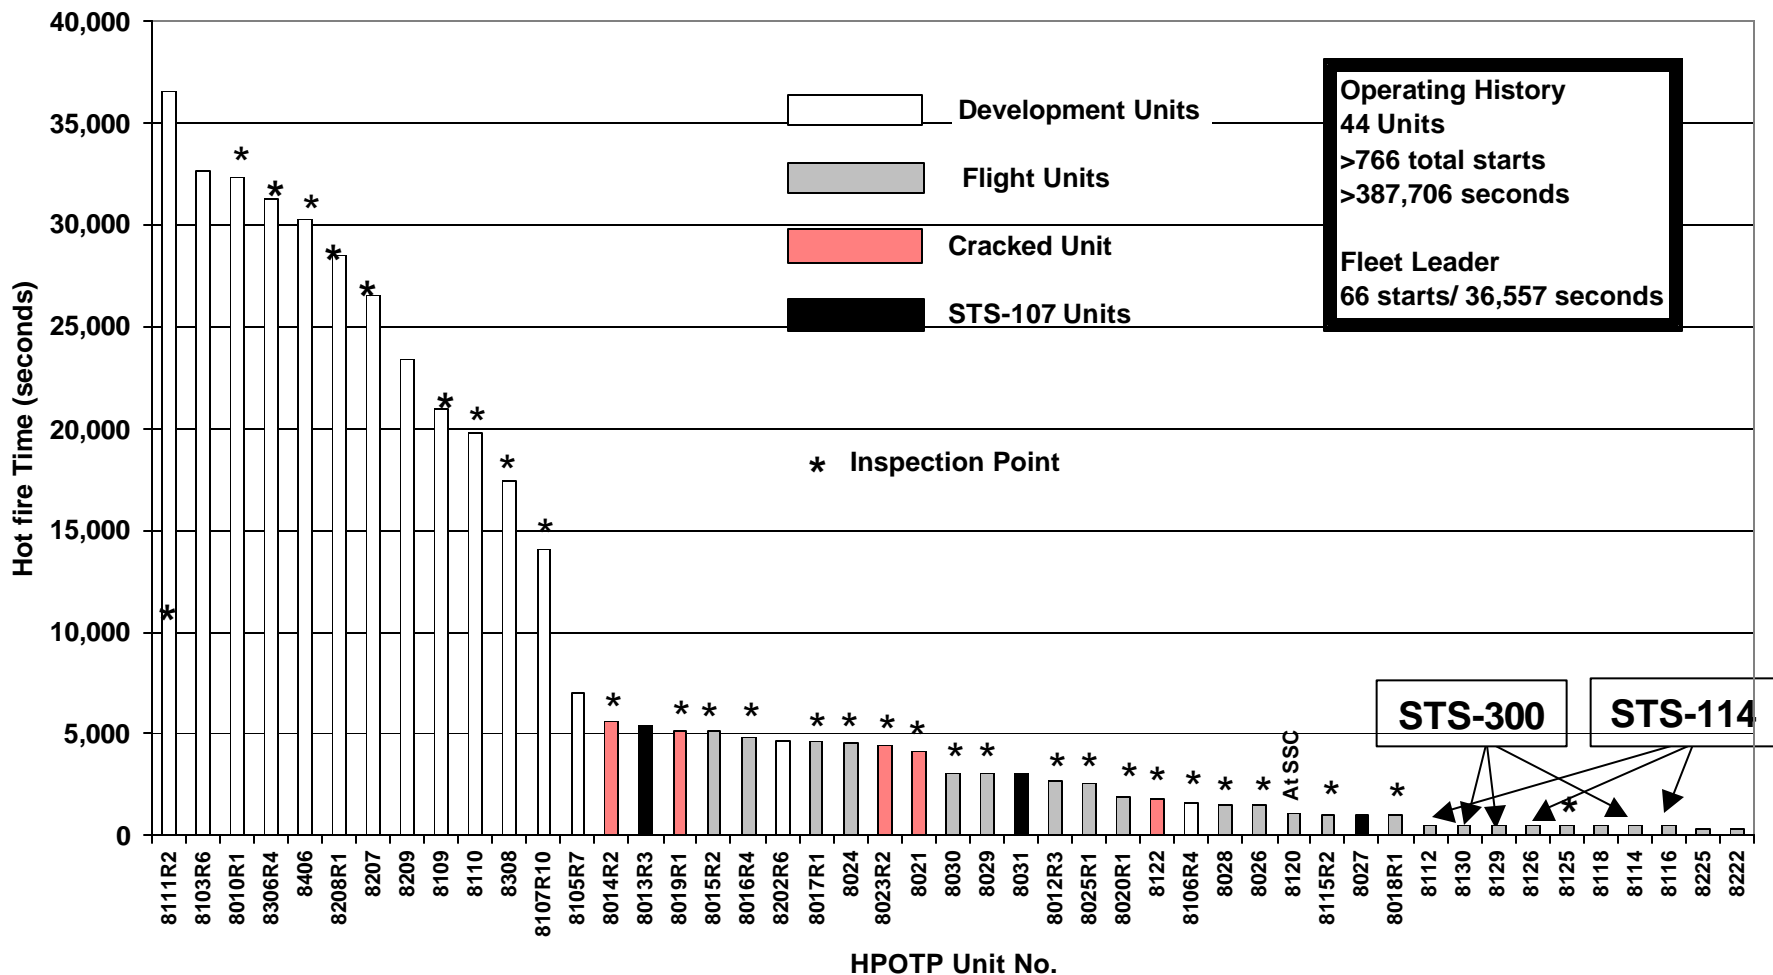
Inboard Seal (-072) Operational History

STS-114 units very low time relative to demonstrated experience with cracking

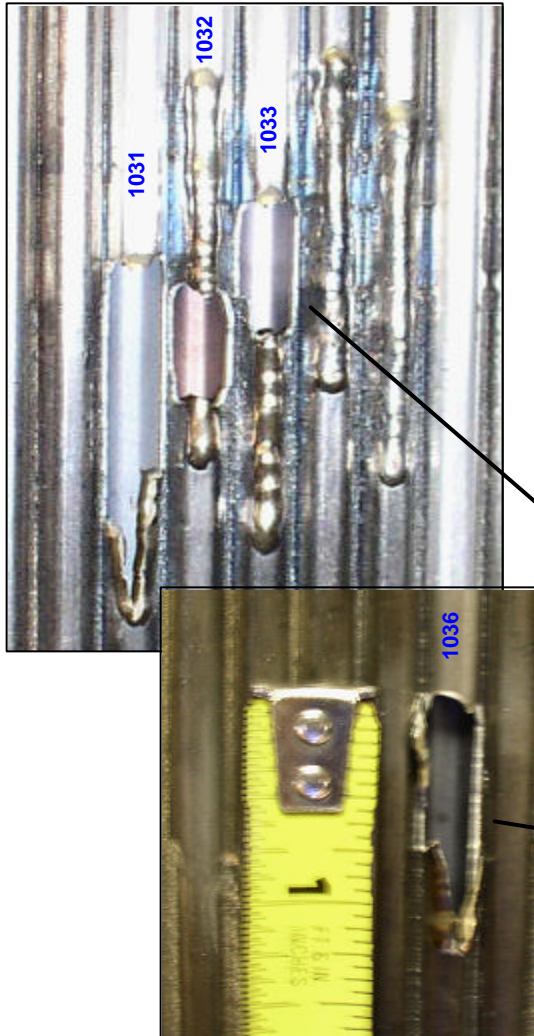
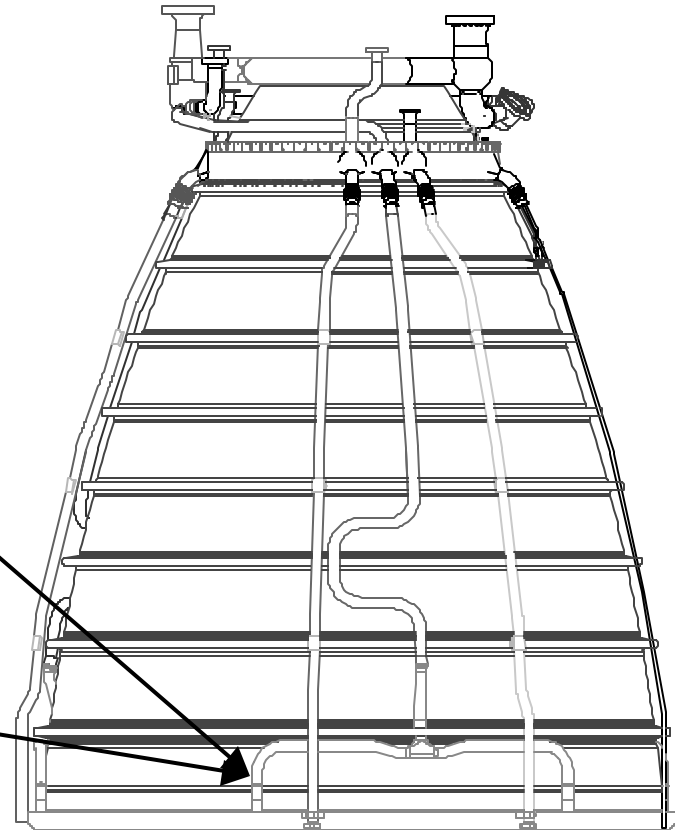
(Tubes 1031, 1032, 1033 and 1036)

- Tube Ruptures located in the 10th bay

- **Unique thermal processing (Uralite bake-out)**
 - Reduced ductility of braze alloy used in previous tube repairs
 - Confirmed with fractography from N5007 fracture surface
 - Atypical overload fracture through overlay centerline
 - Qualitatively duplicated in the lab with bend tests on exemplar repair specimens
 - “As repaired” fractures highly ductile
 - Brittle, limited ductility fractures following 5 hour simulated furnace bake cycle
 - Comparable discoloration as noted in N5007 fractures (gold vs. typical silver)
 - Quantitative verification with tensile specimens
 - Confirmed 63% reduction in ductility
 - Metallography verified nominal material in N5007
 - A-286 tubes, nickel plating and Nicro braze

- **Preliminary Flight Rationale**
 - Nozzle 5007 tube ruptures caused by unique thermal processing
 - Condition does not exist on STS-114 nozzles
 - Comparable tube repairs on STS-114 nozzles have all completed hotfire with no anomalies
- **Forward Action Plan**
 - Complete fault tree and verify closure of all branches
 - Complete laboratory materials analyses of other potential failure mechanisms (ie. anomalous welding)
